NASA/TP-97-206257

The Characteristics of Fatigue Damage in the Fuselage Riveted Lap Splice Joint

Robert S. Piascik
Langley Research Center, Hampton, Virginia

November 1997

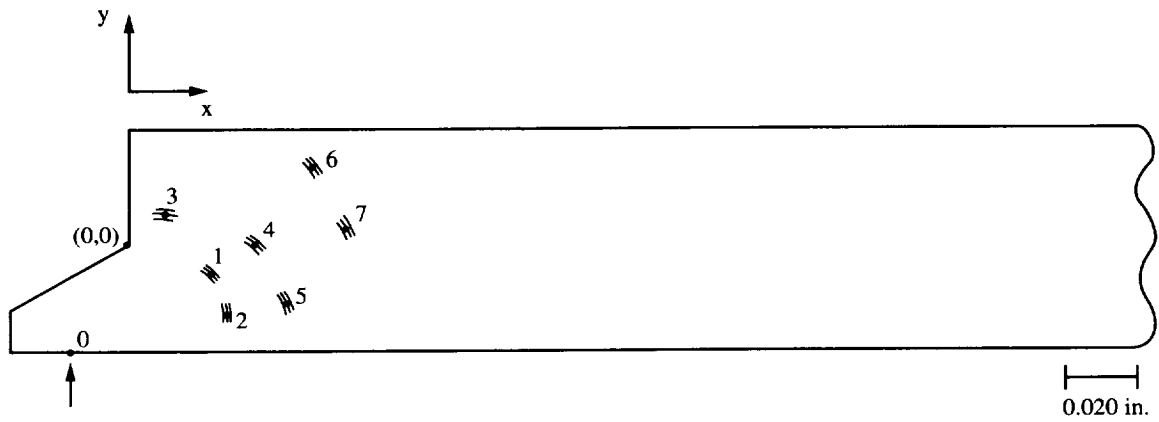
Figure 14.28 The schematic shows the marker band locations for the fatigue crack in rivet hole 4J8 that grew in the aft direction. Three sets of marker bands were found. The fatigue crack initiation region is marked with an arrow. The table summarizes the X-Y marker band coordinates relative to the origin (0,0), and the cycle count for each set of marker bands.

- No Crack front. Crack linked up with 4J8A.

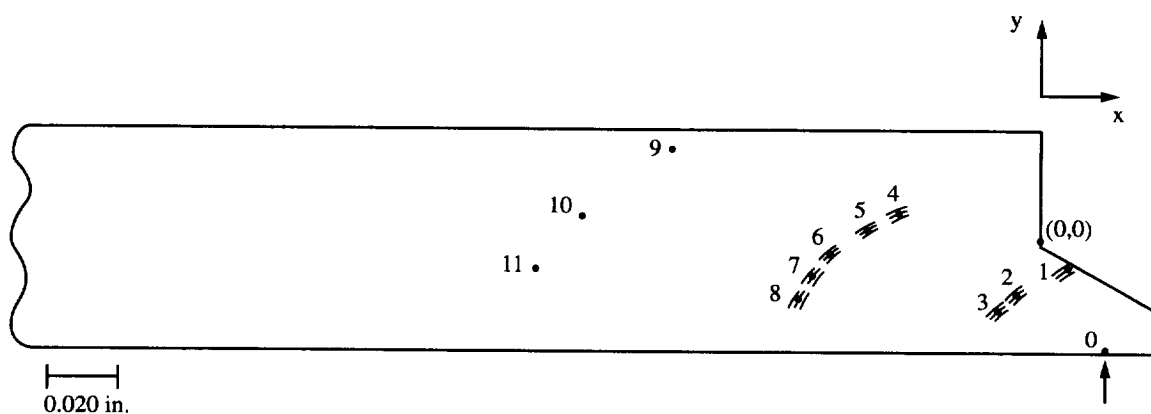
Figure 14.29 The schematic shows the marker band locations for the fatigue crack in rivet hole 4J9 that grew in the forward direction. There were 3 sets of marker bands found. The fatigue crack initiation region is marked with an arrow. The table summarizes the X-Y marker band coordinates relative to the origin (0,0), and the cycle count for each set of marker bands.

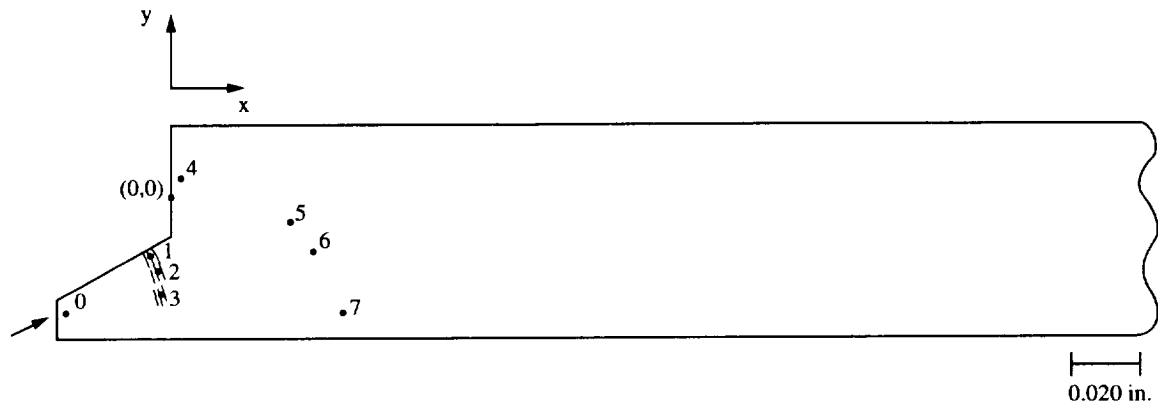
Figure 14.30 The schematic shows the initiation site, marker band and final crack front locations for the fatigue crack in rivet hole 4J10 that grew in the aft direction. Two sets of marker bands were found. The fatigue crack initiation region is marked with a bracket. The table summarizes the X-Y marker band coordinates relative to the origin (0,0), and the cycle count for each set of marker bands.

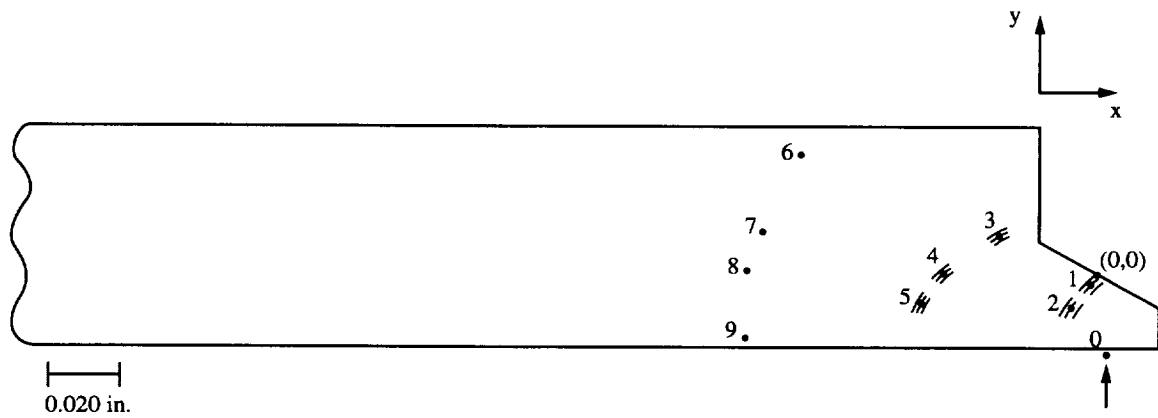
Figure 14.31 The schematic shows the initiation site, marker band and final crack front locations for the fatigue crack in rivet hole 4J12 that grew in the aft direction. One set of marker bands was found. The fatigue crack initiation region is marked with an arrow. The table summarizes the X-Y marker band coordinates relative to the origin (0,0), and the cycle count for each set of marker bands.

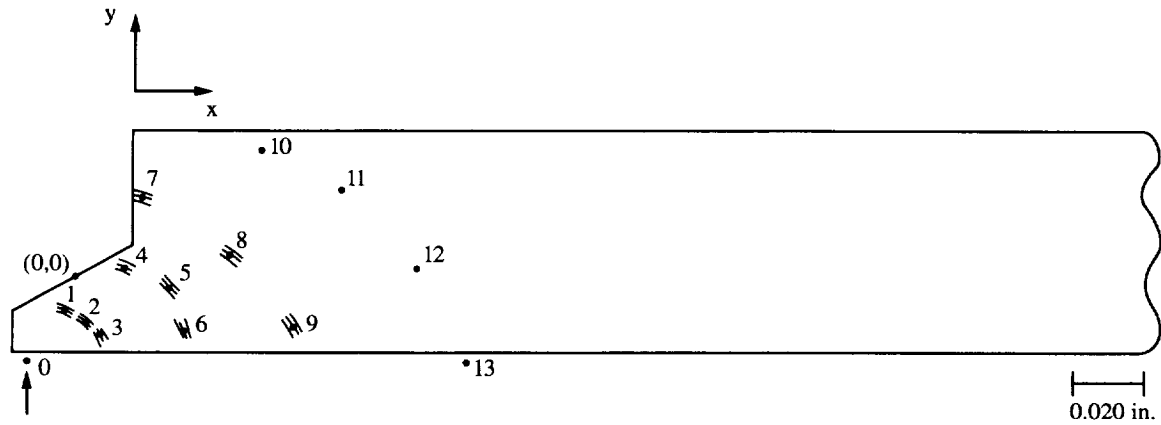
Figure 14.32 The schematic shows the initiation site, marker band and final crack front locations for the fatigue crack in rivet hole 4J14 that grew in the aft direction. Two sets of marker bands were found. The fatigue crack initiation region is marked with a bracket. The table summarizes the X-Y marker band coordinates relative to the origin (0,0), and the cycle count for each set of marker bands.

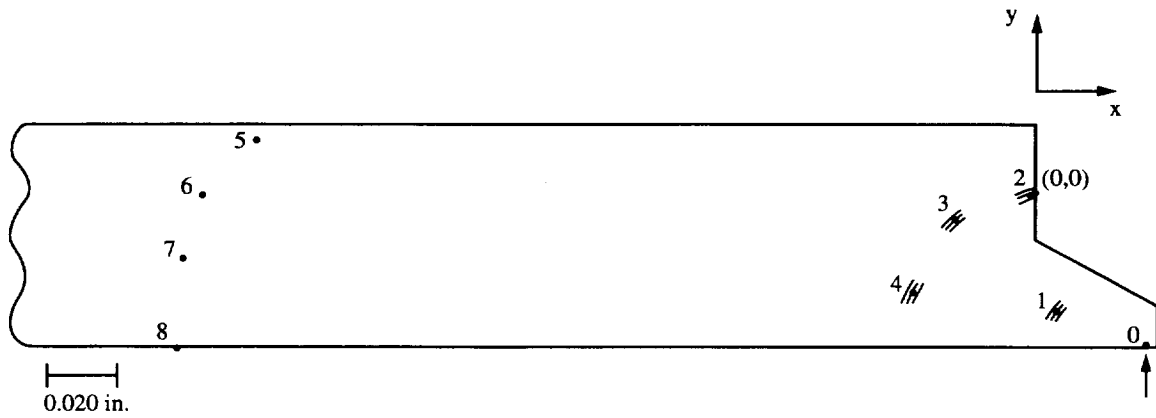
Figure 14.33 The schematic shows the initiation site, marker band and final crack front locations for the fatigue crack in rivet hole 4J14 that grew in the forward direction. Three sets of marker bands were found. The fatigue crack initiation region is marked with an arrow. The table summarizes the X-Y marker band coordinates relative to the origin (0,0), and the cycle count for each set of marker bands.

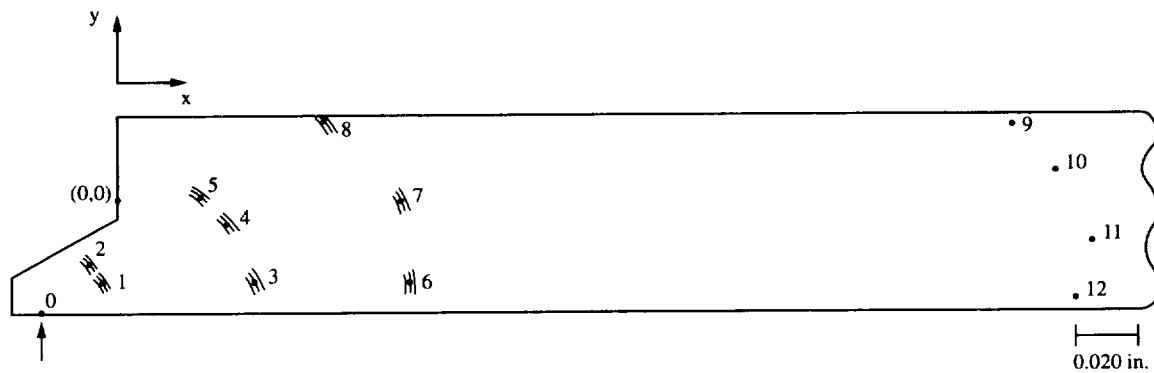
Figure 14.34 The schematic shows the initiation site, marker band and final crack front locations for the fatigue crack in rivet hole 4J15 that grew in the forward direction. Two sets of marker bands were found. The fatigue crack initiation region is marked with an arrow. The table summarizes the X-Y marker band coordinates relative to the origin (0,0), and the cycle count for each set of marker bands.

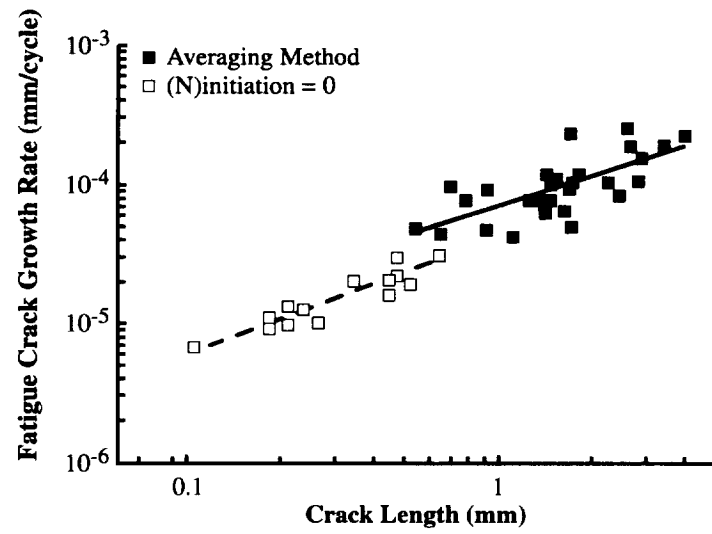
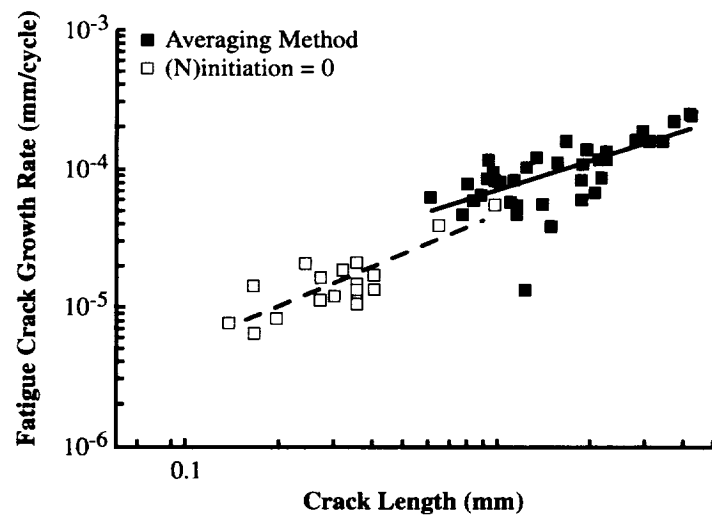
Figure 14.38 The growth characteristics of small fatigue cracks contained in the upper rivet row outer skin in a) bay 3 and b) bay 4.

The outer skin fatigue crack growth characteristics of short cracks, 0.1 mm to 4 mm in length, contained in the upper rivet row were determined by marker band analysis. The results shown in Figure 14.38 reveal that all upper rivet cracks contained in bays 3 and 4 exhibit similar fatigue crack growth characteristics. The da/dN estimates shown in Figure 14.38 for crack lengths between 0.1 mm to 1 mm (open square symbols) are based on the position of a single marker band and the assumption that fatigue cracks initiated at the start of the pressure test ($N_{\text{initiation}} = 0$). A more reasonable estimate of $N_{\text{initiation}}$ can be made based on the crack length history plot shown in Figure 14.37. Extrapolating the crack length versus N plot suggests that the first crack initiation in bay 3 occurred between 10,000 and 15,000 pressure

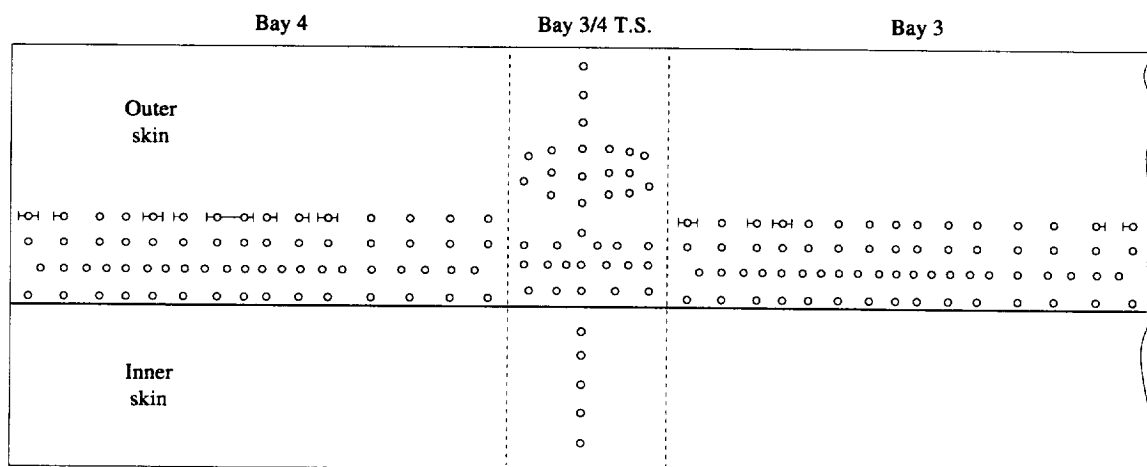
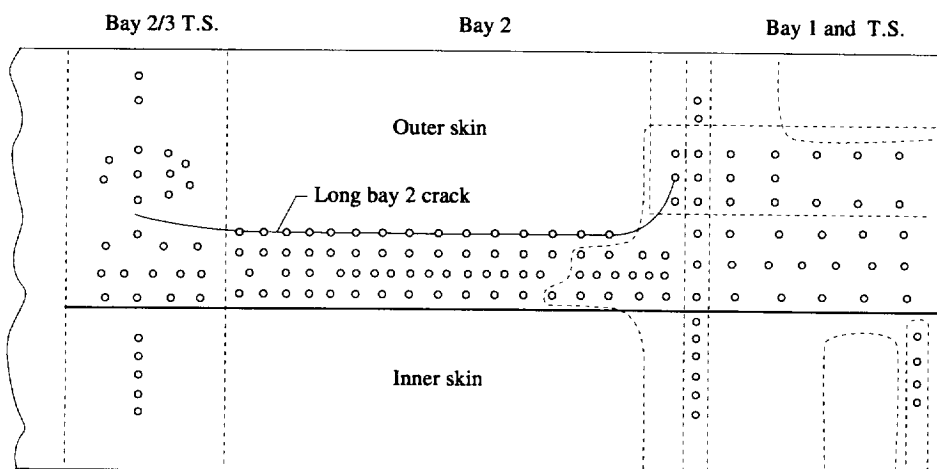
The complete characterization of fatigue cracks contained in the fuselage lap splice was achieved by a detailed teardown and fractographic characterization of the damaged regions. Figures 15.1 and 15.2 show the location of fuselage lap splice joint fatigue cracks as determined by NDE (visual and eddy current inspections) and Figure 15.3 shows the results of the destructive examinations. A comparison of the NDE results in Figures 15.1 and 15.2 show that (1) nearly all upper rivet row hole locations in bays 2, 3, and 4 contained evidence of cracking and (2) the majority of outer skin upper rivet row cracks found by within-hole eddy current inspection in bays 3 and 4 are subsurface and not detected by visual inspection. In addition, surface probe EC inspections revealed subsurface fatigue cracks in the bay 1 tear strap region, the 2/3 and 3/4 tear strap regions, and one indication along the second rivet row in bay 4. A comparison of Figures 15.1 and 15.2 with the destructive examination results shown in Figure 15.3 reveal that visual and EC methods detected cracks at approximately one-half of the rivet hole locations that contained fatigue cracks. Many of the fatigue cracks not detected by NDE were small (below the detection limit of surface probe EC), located under the rivet head, located along the faying surface, and/or contained in interior structure (inner skin, tear strap, or frame).

Figure 15.1 The results of the visual examination are shown for bays 2-4 and tear straps.

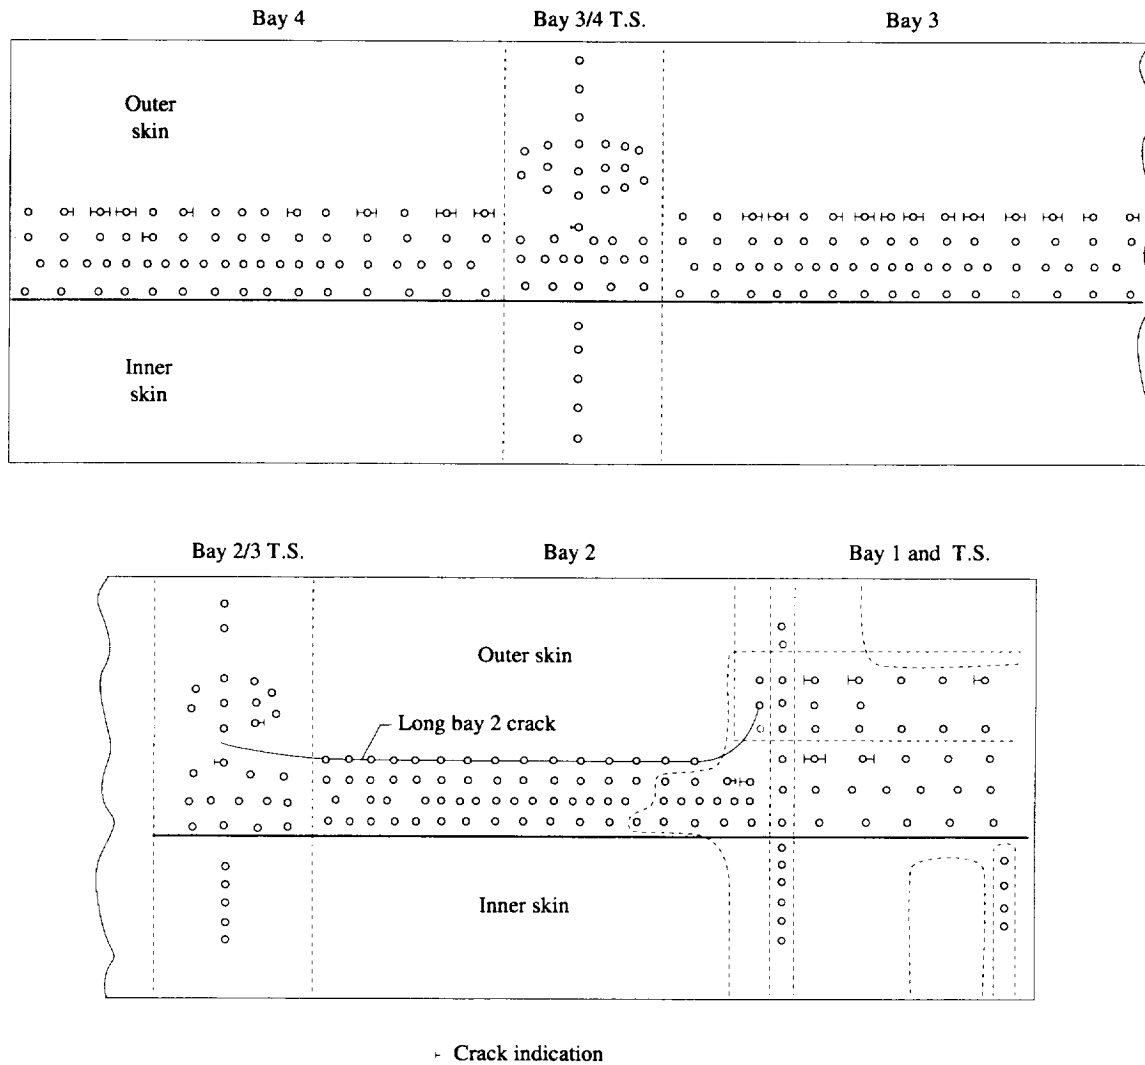
Figure 15.2 The results of the eddy current inspection are shown for bays 2-4 and tear straps. Shown are the locations of non-visible cracks detected by eddy current. All upper rivet holes contained in bays 2, 3, and 4 were examined using a “within” hole EC probe. All other locations were examined using a “sliding” surface EC probe.

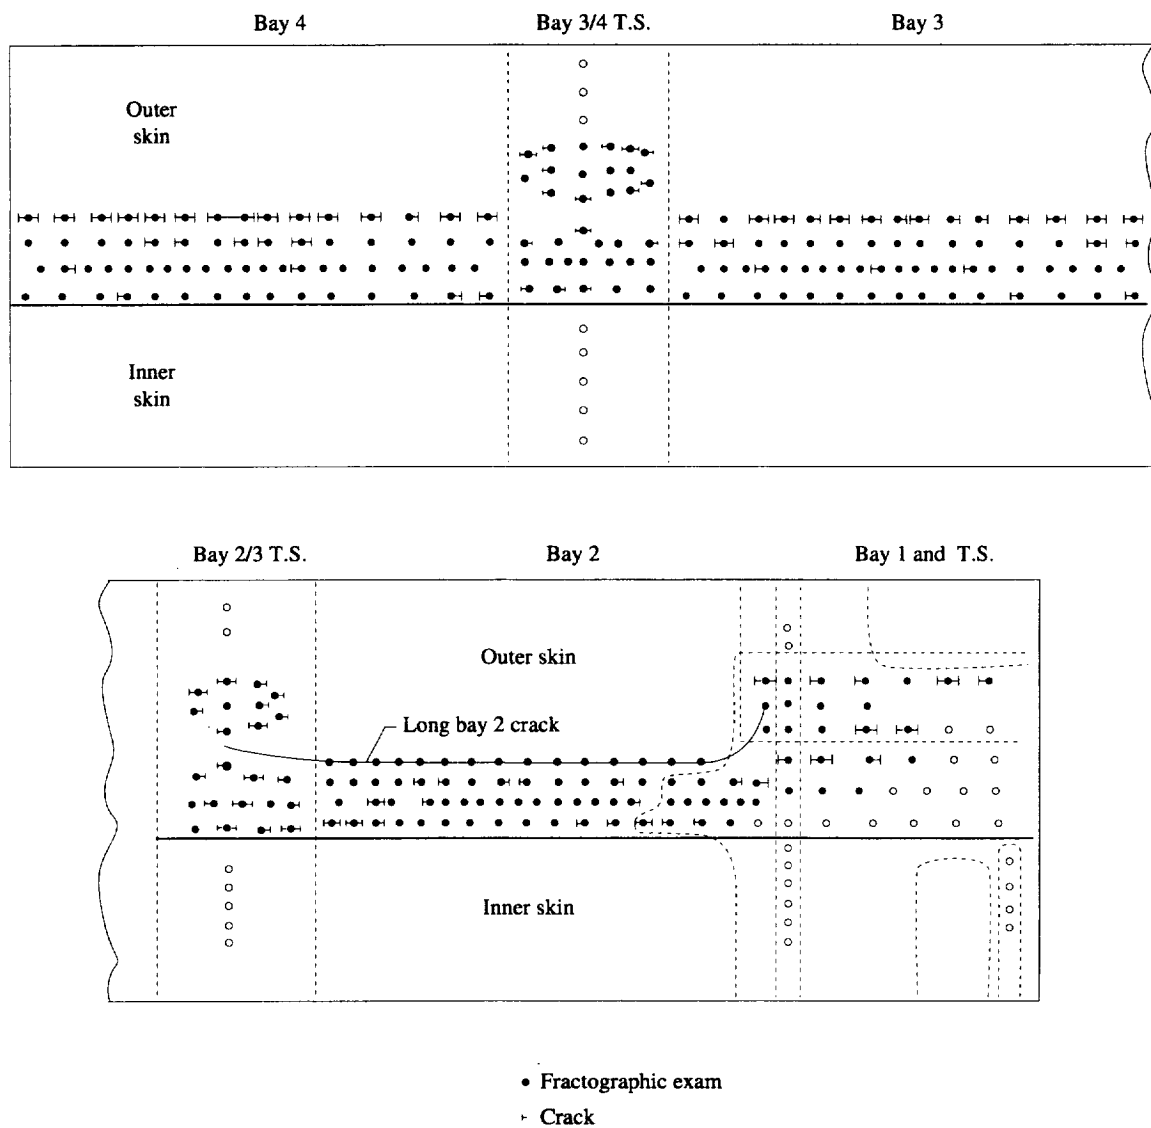
Figure 15.3 The results of the fractographic examination for bays 2-4 and tear straps. Solid rivet holes were destructively examined.

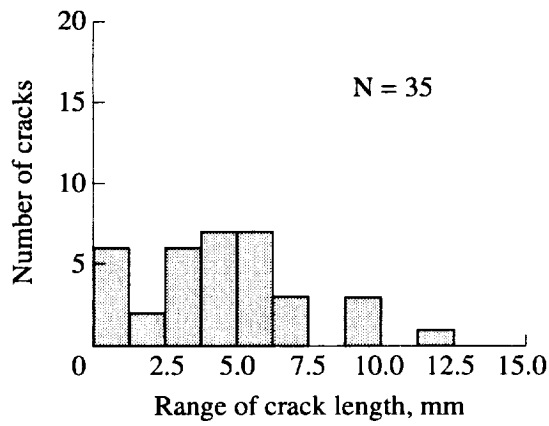
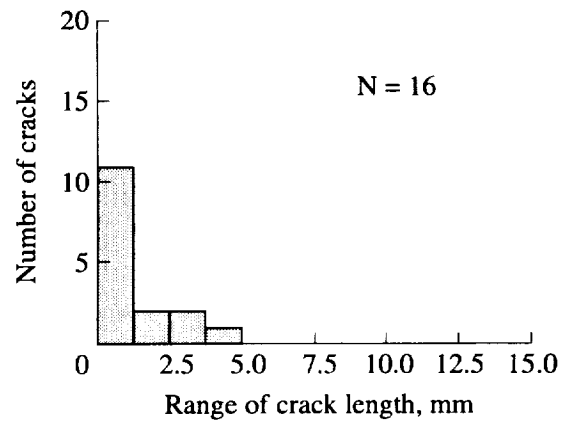
The results of the destructive examination show that lap splice joint MSD is characterized by a wide distribution of crack sizes. Figures 15.4, 15.5, and 15.6 summarize the size distribution of fatigue cracks contained in the outer and inner skin of the bay 2, 3, and 4 lap splice joint. Outer skin fatigue cracks contained in bays 2 and 4 grew to a maximum length of approximately 14 mm (0.55 inch) prior to crack link-up. Inner skin fatigue cracks grew to a length of less than 5.6 mm (0.2 inch) in bay 2 and less than 1.3 mm (0.05 inch) in bays 3 and 4. Presumably, the formation of the long, 47.6 cm (18.75 inch), upper rivet row crack in the outer skin of bay 2 led to a redistribution of load to the inner skin which resulted in significantly more inner skin cracking in bay 2 compared to bays 3 and 4.

Figure 15.4 The fatigue crack size distribution is shown for bay 2 a) outer skin and b) inner skin.

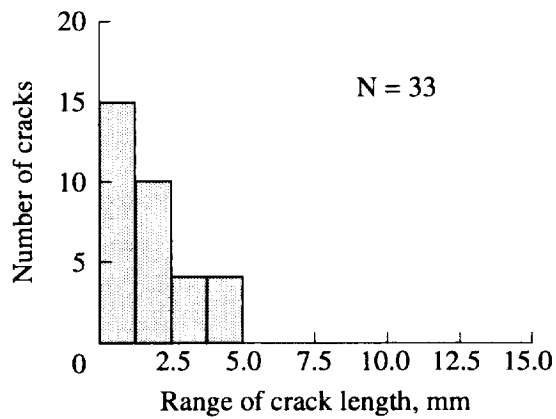
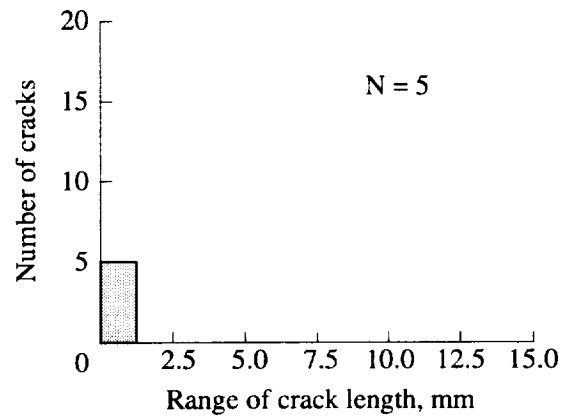
Figure 15.5 The fatigue crack size distribution is shown for bay 3 a) outer skin and b) inner skin.

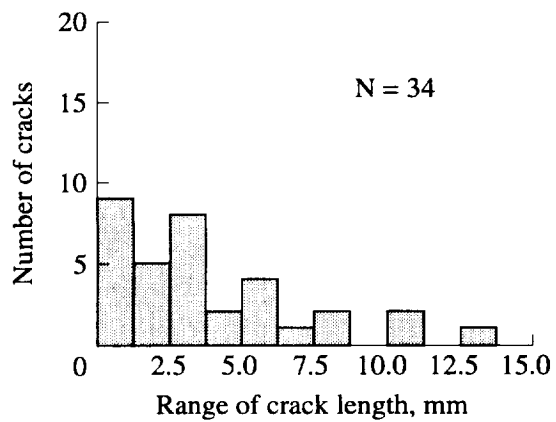
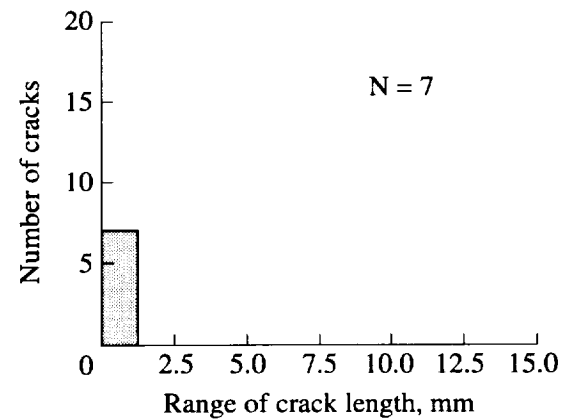
Figure 15.6 The fatigue crack size distribution is shown for bay 4 a) outer skin and b) inner skin.

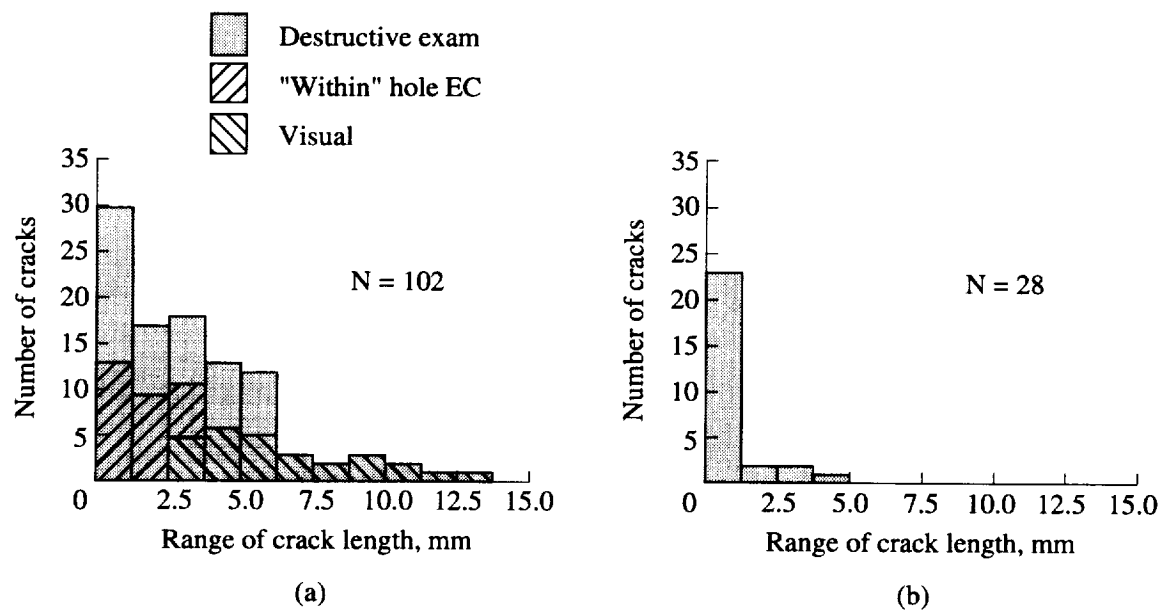
A summary of all fatigue cracks found in bays 2, 3, and 4 lap splice joints is shown in Figure 15.7. Noted in Figure 15.7a are the results of the visual and eddy current outer skin inspections. All outer skin fatigue cracks were detected by “within hole” eddy current inspection. Only outer skin cracks greater than 2.54 mm (0.10 inch) in length were detected by visual examination. The six fatigue cracks not detected by NDE, refer to Figure 15.7a, were located at “filled” hole rivet locations in the second rivet row (row I). Here, the sliding surface probe eddy current technique was unable to detect the presence of these outer skin fatigue cracks. The cracks not detected by surface EC probe ranged in size, four cracks having lengths ranging from 0 to 1.3 mm (0.05 inch), one crack of length ranging between 3.8 mm (0.15 inch) and 5.1 mm (0.20 inch), and one crack of length ranging between 5.1 mm (0.20 inch) and 6.4 mm (0.25 inch). Many of the inner skin cracks were small and were located in filled holes. Here, the within hole EC probe was not used and the surface probe was an inadequate technique to detect inner skin cracks.

Figure 15.7 The total crack size distribution is shown for bays 2, 3, and 4 a) outer skin and b) inner skin.

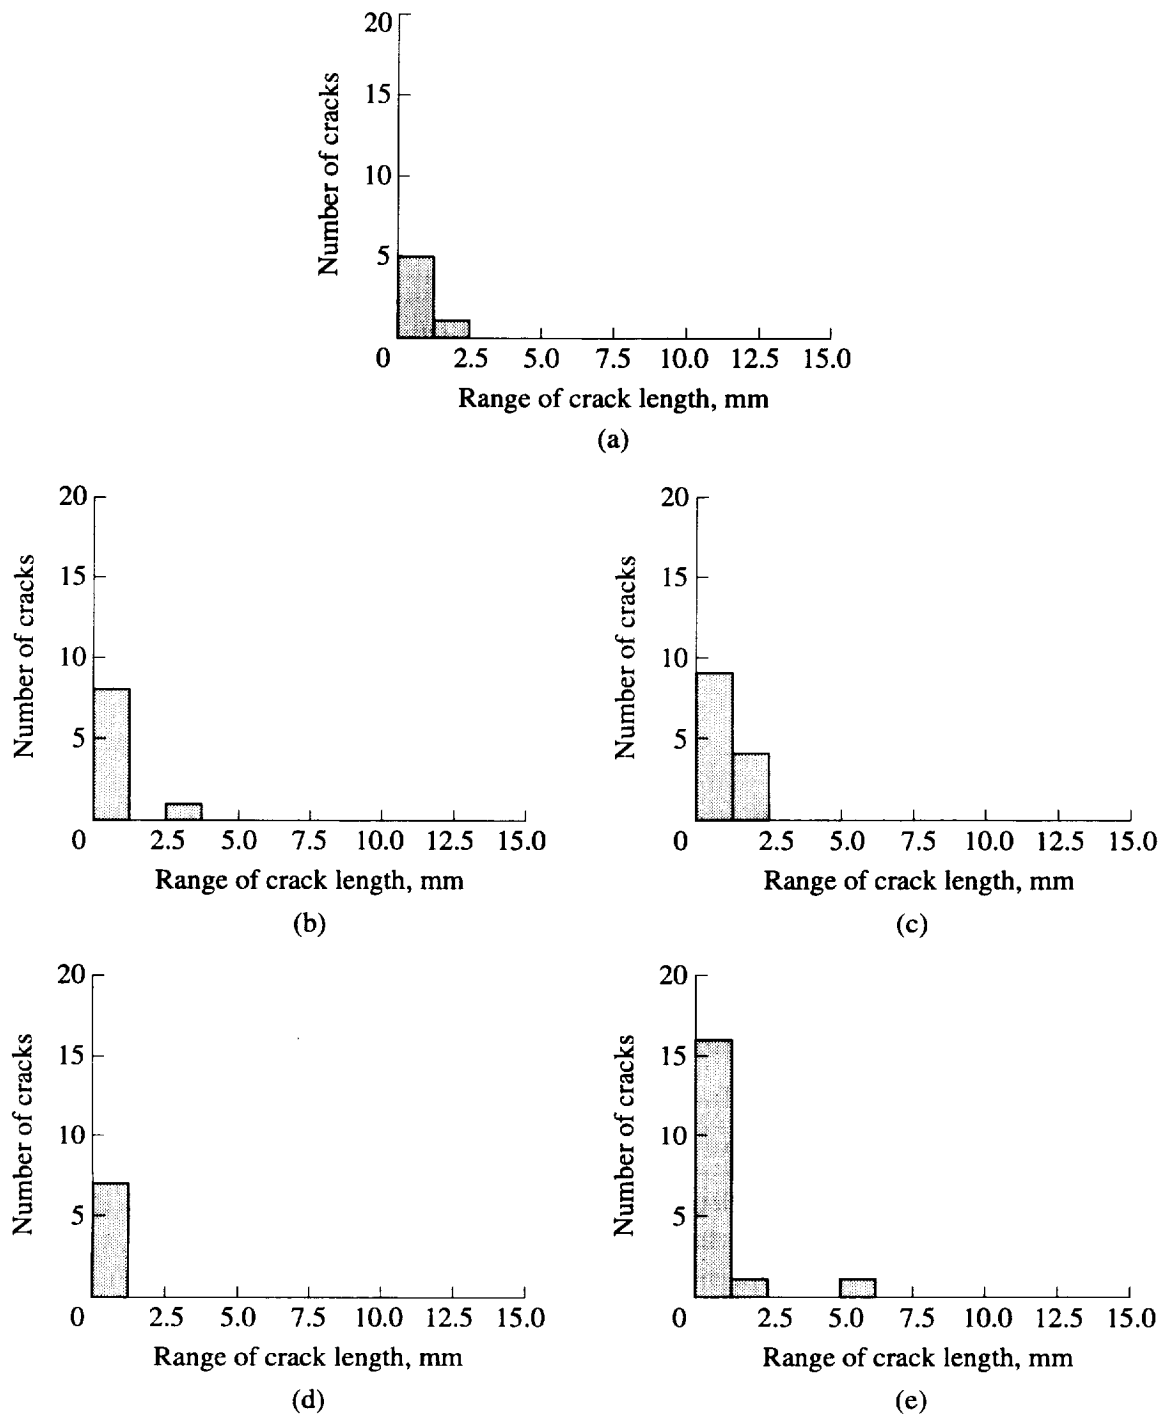
The fatigue cracking in the 2/3 and 3/4 tear strap regions are summarized in Figure 15.8. Here, cracks are generally small, less than 1.3 mm (0.05 inch) in length. A total of eight fatigue cracks having lengths between 1.3 mm (0.05 inch) to 6.4 mm (0.25 inch) were noted in the outer skin, inner skin and tear strap. Tear 3/4 strap region was found to contain the greatest number of fatigue cracks.

Figure 15.8 The crack size distribution is shown for the a) 2/3 TS outer skin, b) 2/3 TS inner skin, c) 2/3 upper and lower TS, d) 3/4 outer skin, and e) 3/4 upper and lower TS.

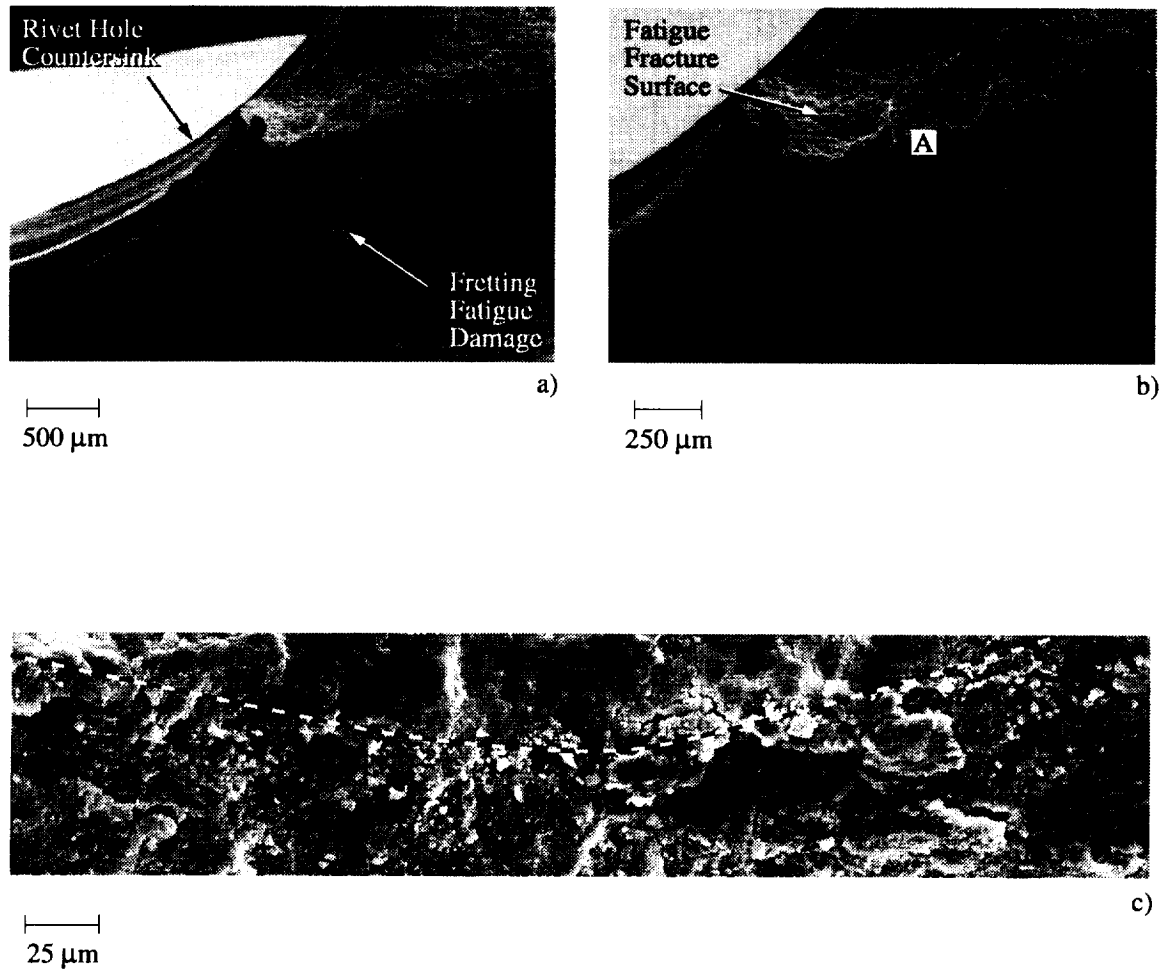
shown in Figures 13.1-13.3 is similar to that reported by Finney and Evans (See ref.2). They showed that fastener hole expansion and interference-fit fasteners can exacerbate faying surface fretting damage by displacing material into the faying surface contact region. Detailed examination of the crack initiation regions along the faying surface, refer to Figure 15.9, revealed that small regions of the ductile clad layer were plastically deformed creating a highly localized damage region characterized by superficial micro-cracking and particle formation similar to that reported by Blanchard et.al. (See ref.3). Figures 15.9a and 15.9b show the fatigue fracture surface and the fretting fatigue damage region along the faying surface adjacent to rivet hole location 3J3FWD. Figure 15.9c shows the typical fretting damage (micro-cracking) and debris in the region of fatigue crack initiation, region A in Figure 15.9b. At each upper rivet hole location, small fatigue cracks (refer to Figures 7.25-7.28 for typical examples) initiated in the clad layer fretting fatigue damaged region resulting in outer skin multiple site cracking.

Figure 15.9 a) Scanning electron micrograph showing the location of faying surface fretting damage at rivet hole location 3J3 in the forward direction. b) SEM micrograph showing fretting damage at higher magnification. c) SEM micrograph showing microcracks and debris at location "A" in Figure 15.9b. The dashed line approximates the location of the fatigue fracture surface (above dashed line) and the faying surface edge (below dashed line).

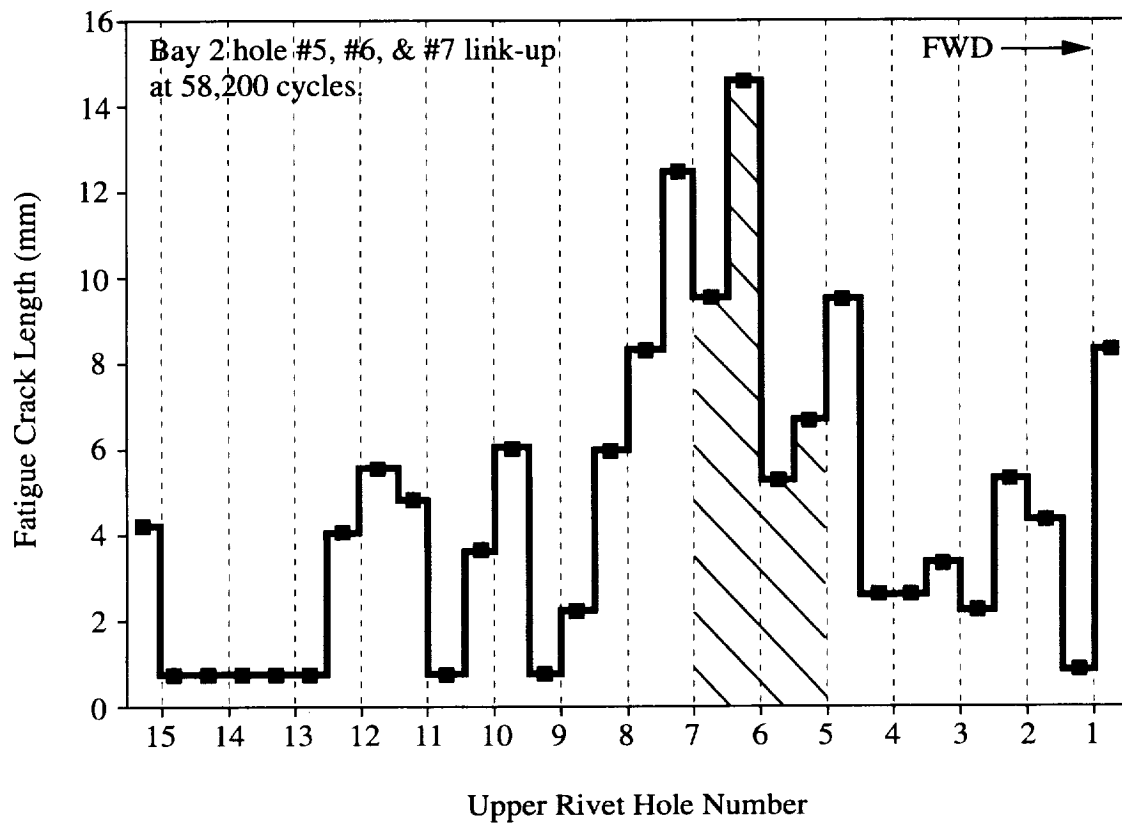
Bays that exhibited crack link-up (bays 2 and 4) contain a similar distribution of fatigue crack lengths. Figures 15.10, 15.11, and 15.12 show the outer skin fatigue crack length at each upper rivet hole location in bays 2, 3, and 4, respectively. These figures represent the condition of each bay very near the end of the full scale fatigue test and immediately prior to crack link-up¹. The bay 2 crack length data plotted in Figure 15.10 are based on *in situ* visual examinations conducted at fix pressure cycles; here, first link-up was observed between 58,040 and 58,200 pressure cycles and the remainder of the fatigue cracks linked between 58,200 and 58,500 pressure cycles. Figure 15.12 shows bay 4 fatigue crack lengths prior to crack link-up at 59,900 cycles. The fatigue crack distribution shown in Figure 15.11 for bay 3 at 60,000 pressure cycles

¹Crack link-up occurred in bays 2 and 4. Because of fracture surface oxide debris, the exact location of the final fatigue crack front was not determined by fractography in bay 2. *In situ* visual crack length data are plotted in Figure 15.10. These results estimate the location of the crack front within 160 to 300 cycles prior to crack link-up (58,200 cycles). The fractographic based results for bay 4, shown in Figure 15.12, represent the condition of bay immediately prior to crack link-up (59,900 cycles). The fractographic based for bay 3 in Figure 15.11 represent the condition of the bay at the end of the pressure test (60,000 cycles).

Figure 15.10 A plot of fatigue crack length prior to link-up for outer skin upper rivet row cracks contained in bay 2. Crack link-up occurred between rivet holes 5-7 (shaded region) between pressure cycles 55,500 and 58,000. Link-up occurred at other hole locations between pressure cycles 58,200 and 60,000.

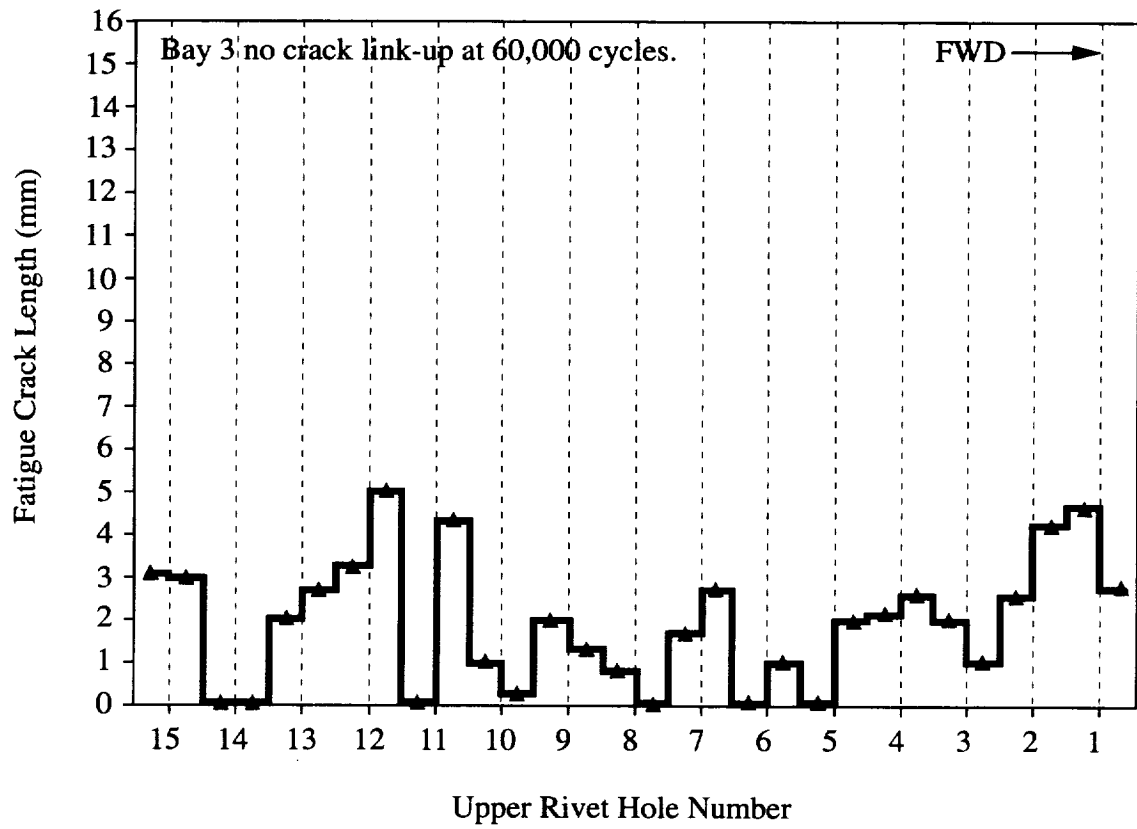
Figure 15.11 Shows bay 3 fatigue crack lengths at 60,000 cycles; no crack link-up occurred in bay 3.

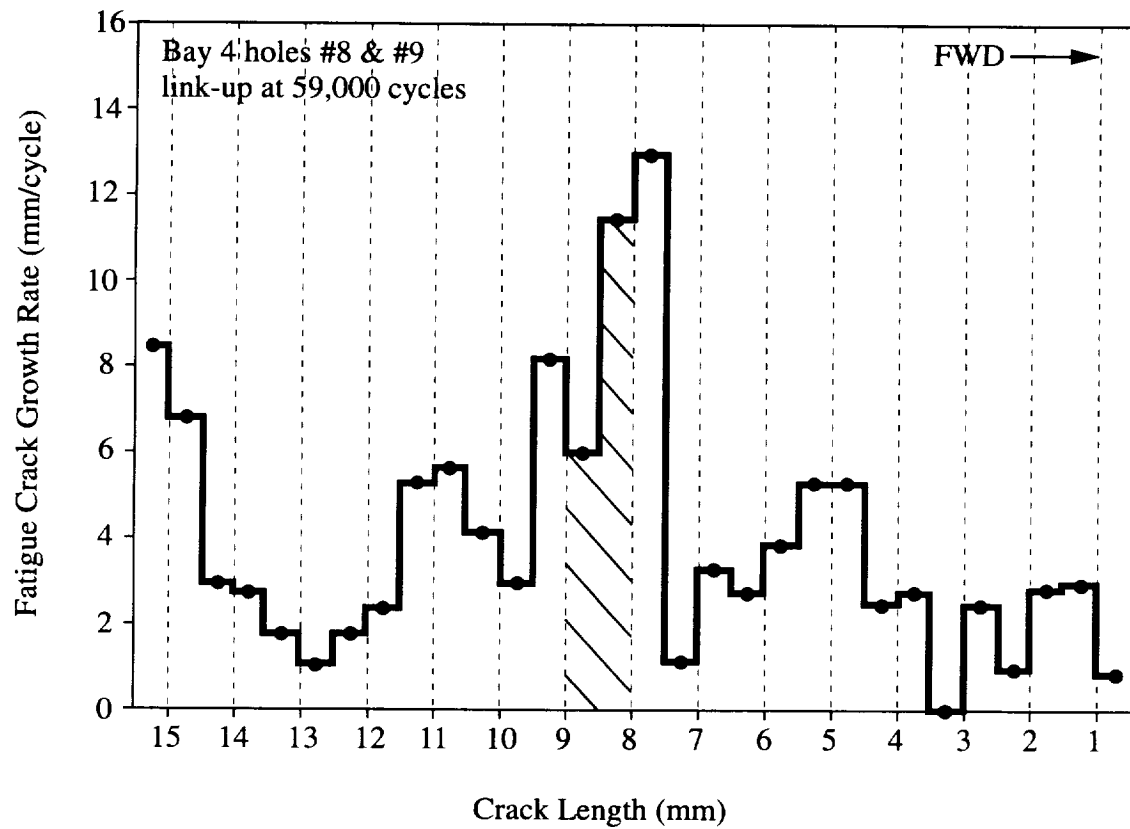
Figure 15.12 A plot of fatigue crack length prior to link-up for outer skin upper rivet row cracks contained in bay 4. Crack link-up occurred between rivet holes 8 and 9 (shaded region) at 59,900 pressure cycles

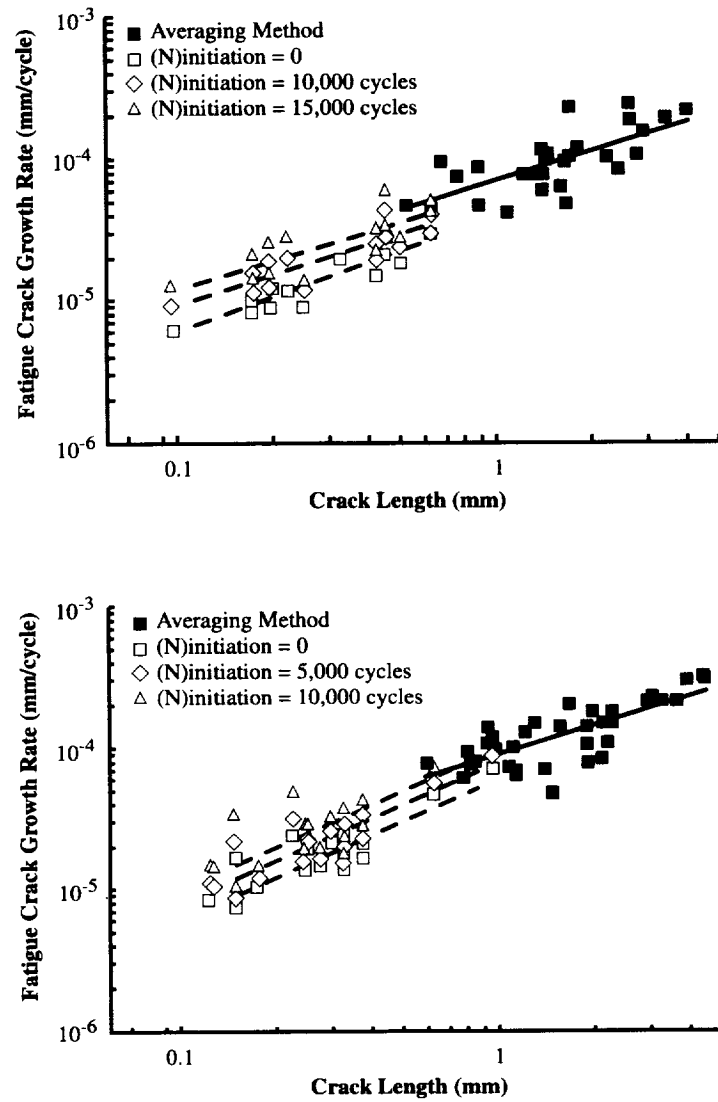
cycles and bay 4 crack initiation occurred between 5,000 and 10,000 pressure cycles. Plotted in Figure 15.13 are the estimated short crack da/dN results (open triangles and diamonds) for extrapolated values of $N_{\text{initiation}}$. A comparison of the linear regression analysis lines for bays 3 and 4 ($N_{\text{initiation}} = 15,000$ and 10,000 cycles, respectively) with the long crack data (solid square symbols) strongly suggests that a single curve describes the growth behavior of upper rivet row fatigue cracks in each lap splice joint bay. A comparison of the fatigue crack growth characteristics for bays 3 and 4 is shown in Figure 15.14. Here, the linear regression analysis lines for bays 3 and 4 are in good agreement. This important result suggests that all outer skin fatigue cracks contained in the lap splice joint upper rivet row propagate at the same rate. The linear behavior of the log da/dN versus log a plot may suggest that complex local stresses, such as that resulting from rivet fit-up, have little effect on da/dN for fatigue cracks greater than 1 mm in length. If local stresses were significant, a non-linear da/dN versus a response would be expected as the crack grew out of a local stress environment into the remote stress dominated regime.

Figure 15.13 The growth characteristics of small fatigue cracks contained in the upper rivet row outer skin in a) bay 3 assuming $N_i=0$, $N_i=10,000$ cycles, and $N_i=15,000$ cycles and b) bay 4 assuming $N_i=0$, $N_i=5,000$ cycles and $N_i=10,000$ cycles.

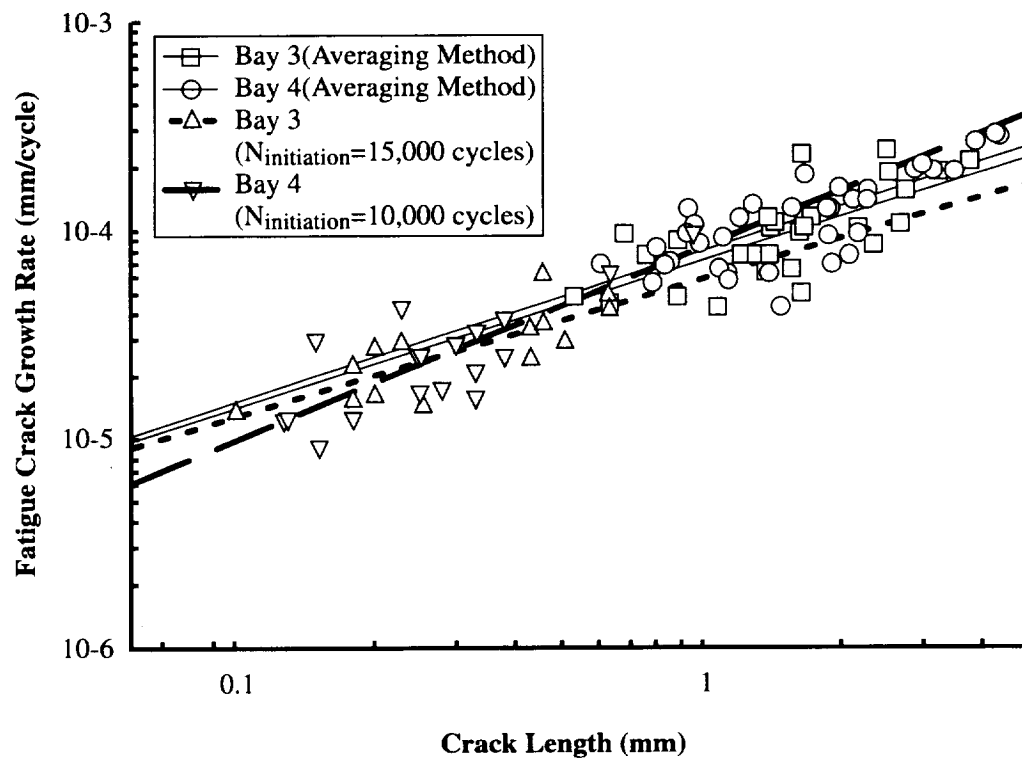
Figure 15.14 A comparison of the growth characteristics of outer skin fatigue cracks contained in bays 3 and 4 lap splice joint upper rivet row.
